AN EVALUATION OF  
BLIGHT CONDITIONS REPORT

PREPARED FOR  
THE CITY OF BREMERTON.

BY  
WILLIAM B. REEMS  
C.C.I.M., C.R.B., C.R.S.  
SENIOR CERTIFIED APPRAISER

Re: Blight Evaluation

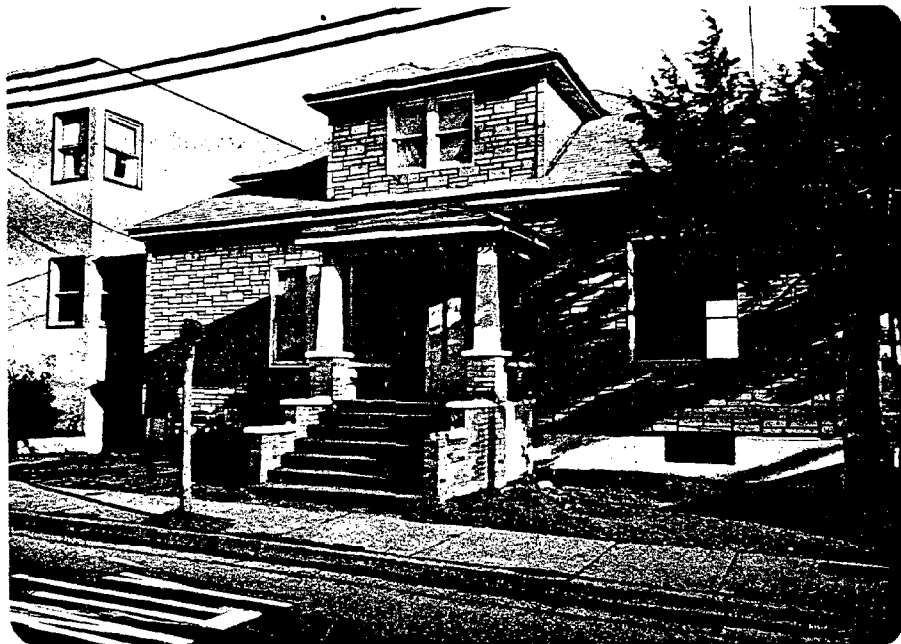
MAP REFERENCE NUMBER 35 (CONTINUED)

view looking east at subject fronting  
Washington Ave.

CONDITION Fair condition showing signs of physical  
deterioration and functional obsolescence.

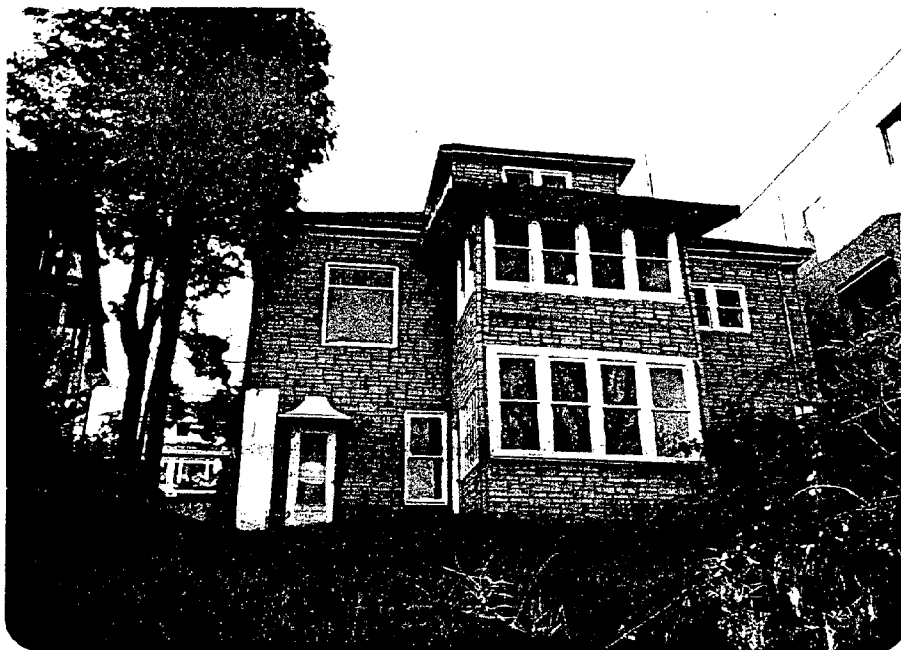
Second dwelling on property has been removed.

rear view of subject looking west

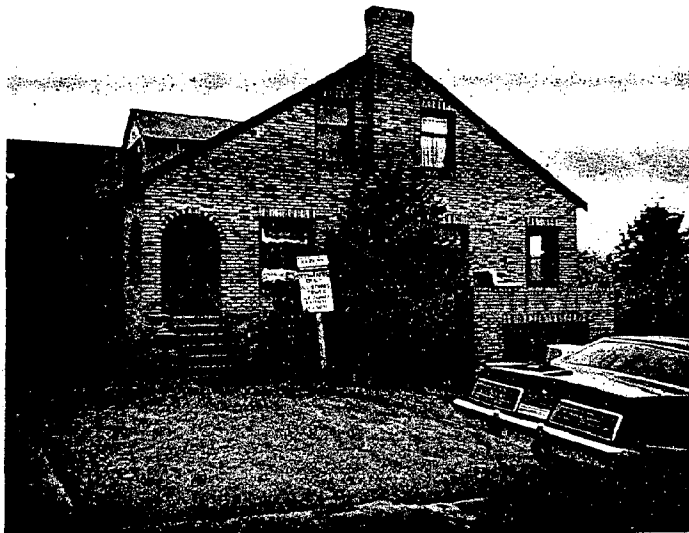
MAP REFERENCE NUMBER 37 (CONTINUED)

view of west and south side of subject

CONDITION Fair condition shouing some physical deterioration  
and functional obsolesence.

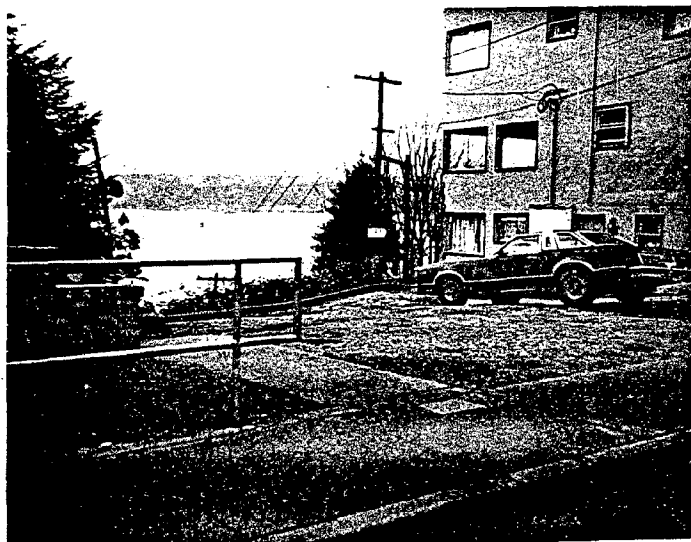
view looking southeast at parking area.

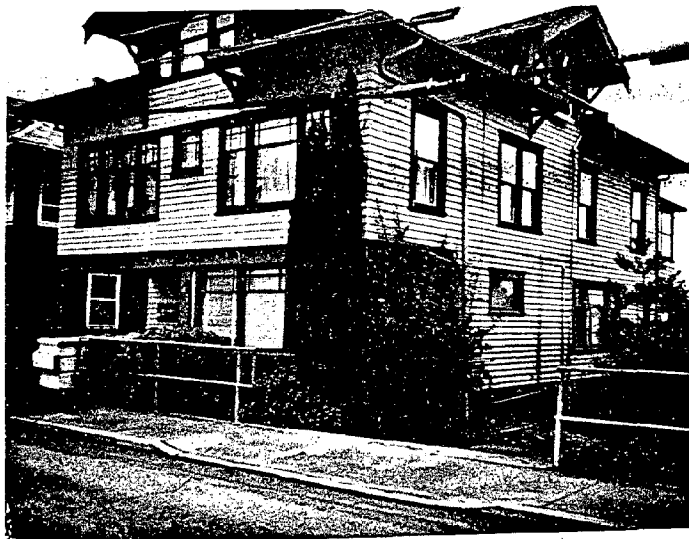
MAP REFERENCE NUMBER 38 (CONTINUED)

view looking northeast at subject

CONDITION Fair condition with some physical deterioration  
and functional obsolesence. No vehicle parking on or near  
the site.

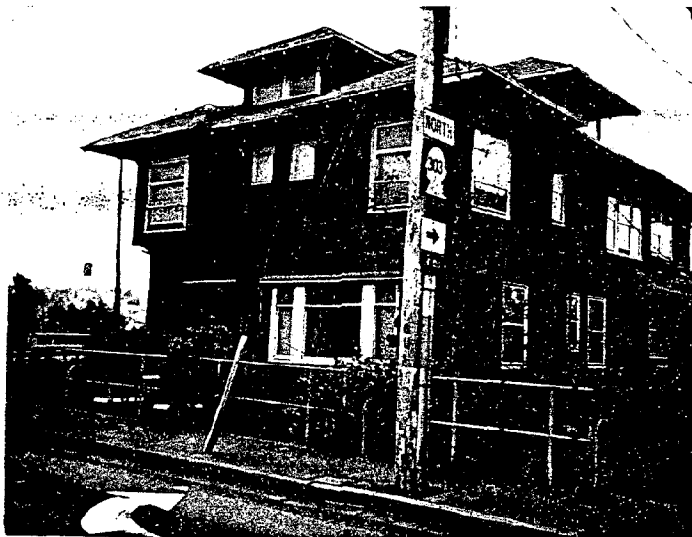
MAP REFERENCE NUMBER 39 (CONTINUED)

view looking northeast at subject

CONDITION Fair condition showing physical deterioration
